# Is That FOD or an CAD About

By AME1 Randall Brogdon

# Ejection Seat to Fire?

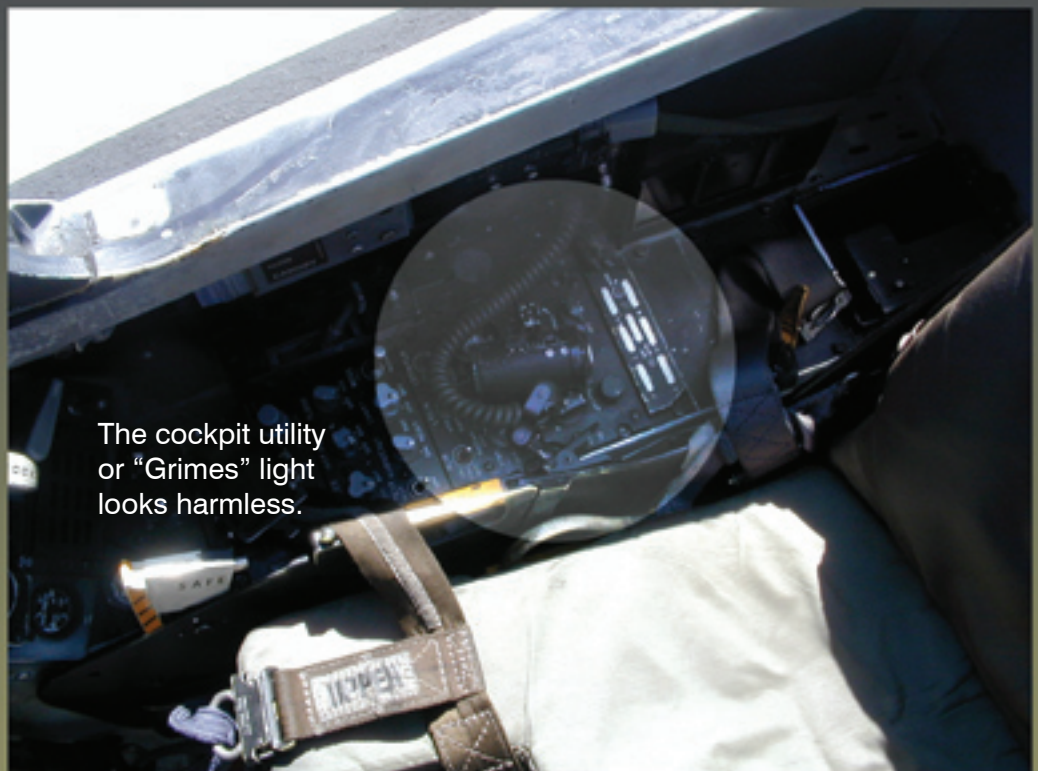
The cockpit utility or "Grimes" light looks harmless.

After investigating this problem, we concluded the utility light in the cockpit had jammed against the seat bucket as the pilot lowered the seat. That light caught on the linkage and bent it, gradually pulling the pin from its normal position. Had the MOR cartridge fired on deck, the pilot’s restraints would have released. The drogue gun also would have fired the drogue chute through the canopy glass, and the time-release mechanism would have fired, deploying the parachute through the canopy.

The squadron issued a hazrep about this hazard. Our aviators use NVG-compatible finger lights or similar light products, so we have little need for the utility or “Grimes” light. We have requested that NavAir investigate removing this item to avoid a similar incident.
